Downbursts, groundings, incompetence and other hazards to 21st century merchant sailing ships

Sergio E. Perez, U.S. Merchant Marine Academy Department of Marine Engineering, Kings Point NY, perezs@usmma.edu

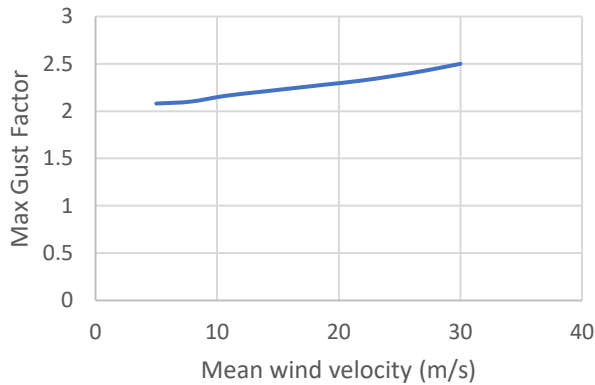
Figure 1. Maximum gust factor (gust velocity/mean wind velocity) from Forristall's method (Forristall, 1985), using data from Gulf of Mexico and North Sea, with maximum wave heights corresponding to mean wind velocity.

heights), resulting in Figure 1 below. The plot shows the maximum Gust Factor (Gust Maximum/Average Wind Speed) as a function of average wind speed.

The plot shows that maximum gust factors range from 2.1 at 5 m/s to 2.5 at 30 m/s. This is in direct contrast to storm gusts over land, which show decreasing gust factors with wind speed. The increase appears to be due to the effect of waves.

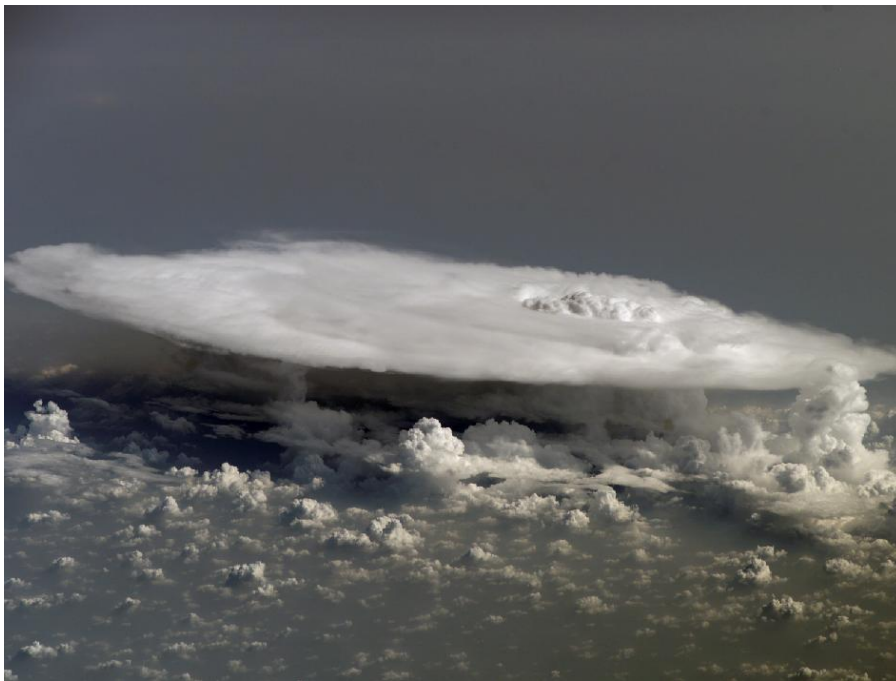
Figure 2. Cumulonimbus anvil cloud, photographed from International Space Station.

- **Cumulonimbus** clouds may cause wet or dry microbursts which descend from the dark base of the cloud, often accompanied by lightning and hail nearby.
- **Spreading Anvil Cumulonimbus** clouds may develop dry microbursts beneath the long precipitation streaks falling from a spreading anvil of a dissipating cumulonimbus. Due to the evaporation during the long descent, practically all of these microbursts are dry. However, the outburst winds may be very strong.
- **Cumulus Congestus** clouds develop streaks of virga (rain that evaporates before striking the surface) that may have an innocuous appearance, but the virga could induce strong microbursts lasting 2 to 3 minutes.
